ONE GOOD TURN

AN EASY UPGRADE FOR YOUR WORN STEERING GEAR

WORDS AND PHOTOGRAPHY BY CHUCK HANSON

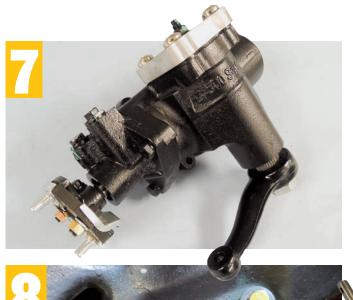
After bolting the new CPP steering box in place, we found that our Chevelle's steering wheel was improperly indexed by 180 degrees. The rag joint mates to the steering shaft with a pair of bolts, one larger than the other, to ensure that it can only be assembled with the correct orientation. Research led us to a different rag joint that bolted to the new steering box and maintained proper indexing. We don't know if this was an assembly line anomaly, if a previous owner swapped steering columns, or if we simply ordered the wrong part with the steering box. Our easy solution was to substitute a Dorman rag joint, part number 31011.

Using the steering shaft retaining bolt as a reference, the different-sized bolts that retain the CPP rag joint (L) and the Dorman substitute (R) are quite discernible.
