PROJECT CAR UPDATE

Wires, Columns, Quarters, and Clutches

By John McGann / Photos: John McGann

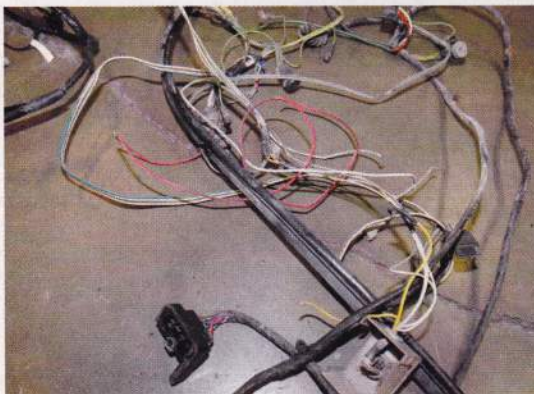
We need this pickup to be daily driver reliable, and one thing we have no time for is electrical problems. The truck's rear wiring harness was a butchered mess of splices and dead-end, taped-off wires, the result of a poorly installed trailer harness. We removed it and the engine-compartment harnesses for replacements from American Autowire, sold through Classic Industries.

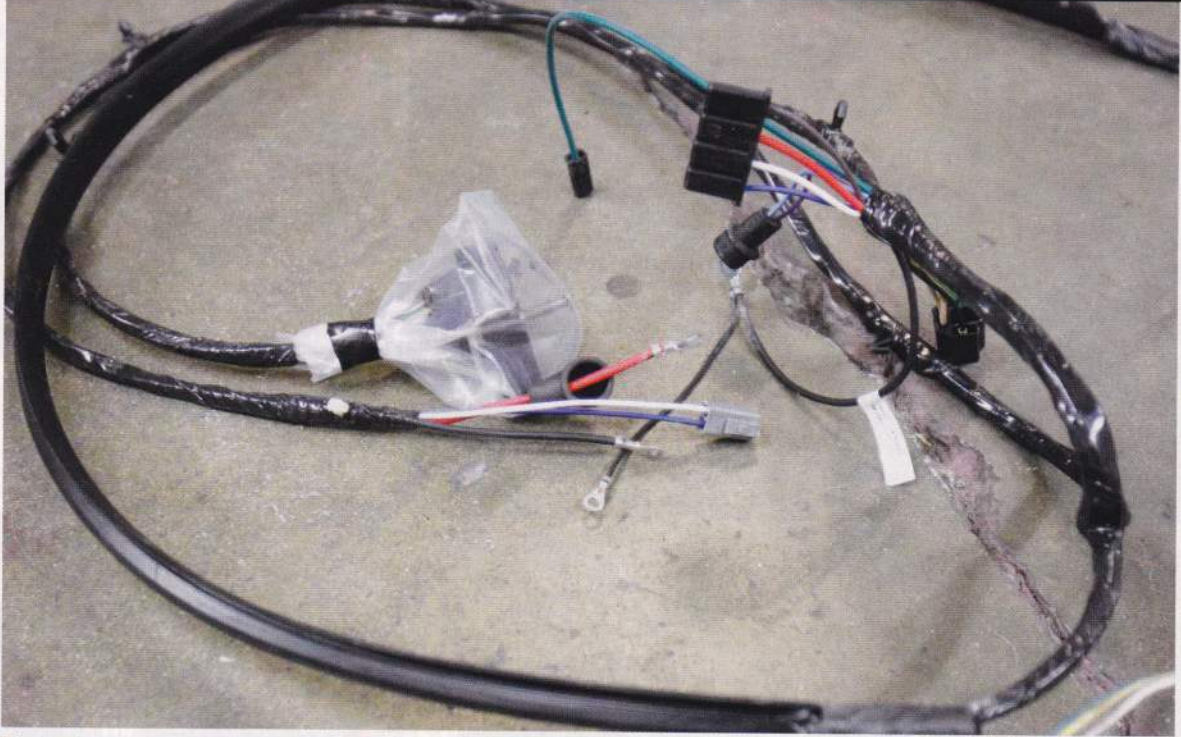
The new harnesses are exact replacements of the originals. This is the front engine-compartment harness, which includes the correct bulkhead connector and plastic channel that runs across the radiator core support to power the headlights and turn signals.

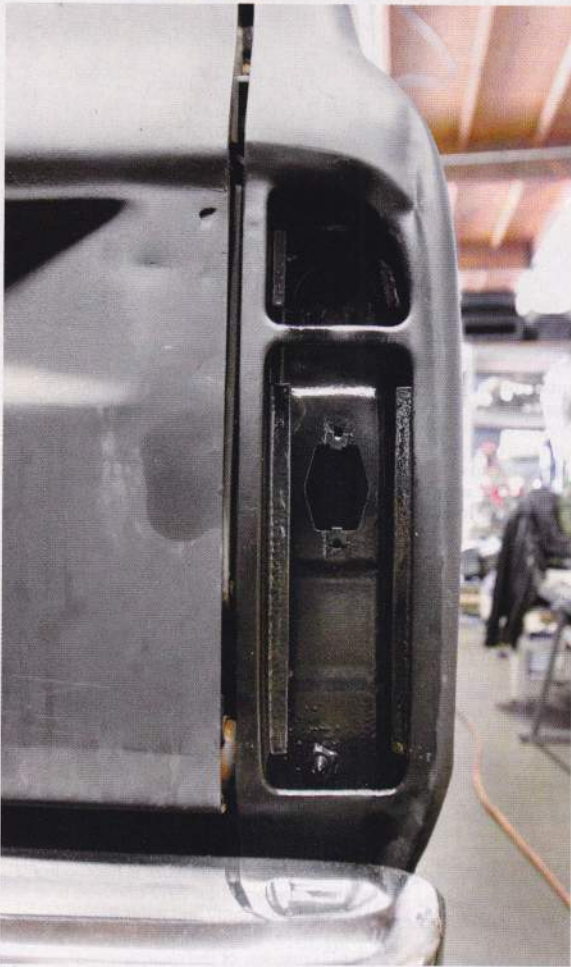
While the wiring was out, we took the opportunity to clean some of the grime behind the rear lights and treated the area with Eastwood's Rust Encapsulator.

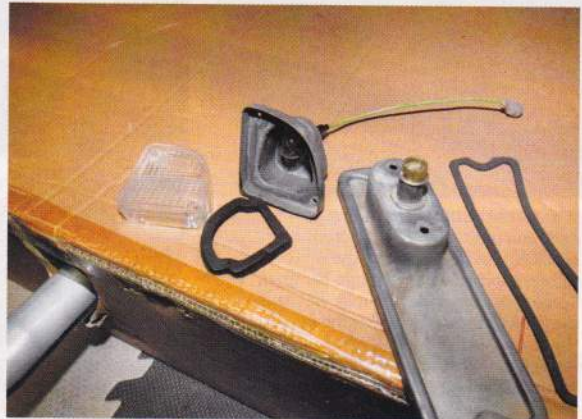
We also cleaned the lamp sockets with a wire brush and reassembled them with new back-up lenses from Rock Auto and gaskets from Brothers Trucks. We recommend using dielectric grease on the bulb receptacles. It protects electrical connections from corrosion, which is especially useful in an area like this as it becomes contaminated with dirt and moisture over time.

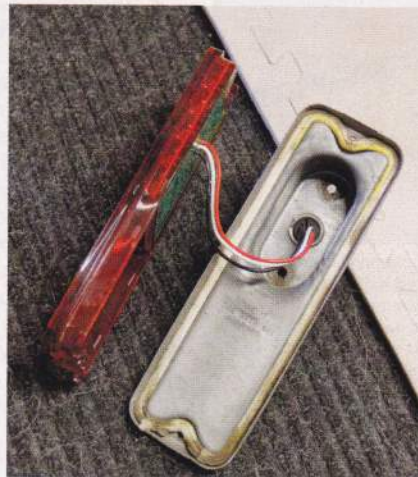
We reinstalled the taillights with these LED replacements from Classic Industries. The LEDs are built into the lens with a pigtail that plugs into the stock lamp socket.

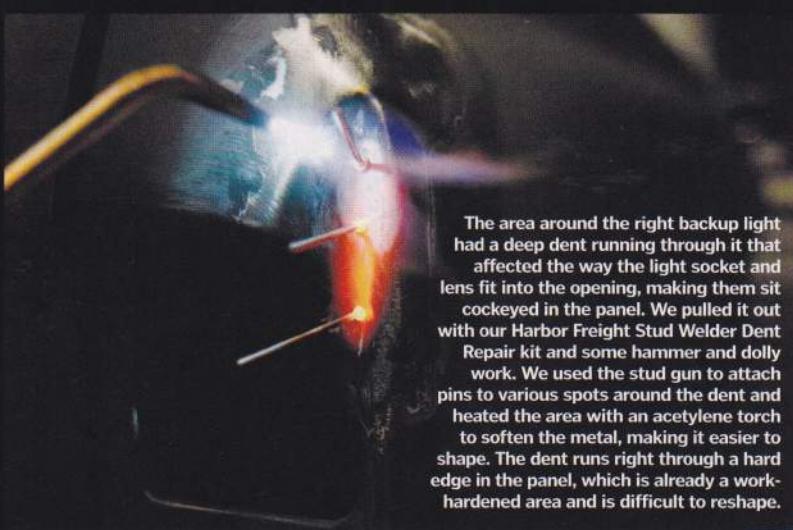
The area around the right backup light had a deep dent running through it that affected the way the light socket and lens fit into the opening, making them sit cockeyed in the panel. We pulled it out with our Harbor Freight Stud Welder Dent Repair kit and some hammer and dolly work. We used the stud gun to attach pins to various spots around the dent and heated the area with an acetylene torch to soften the metal, making it easier to shape. The dent runs right through a hard edge in the panel, which is already a work-hardened area and is difficult to reshape.

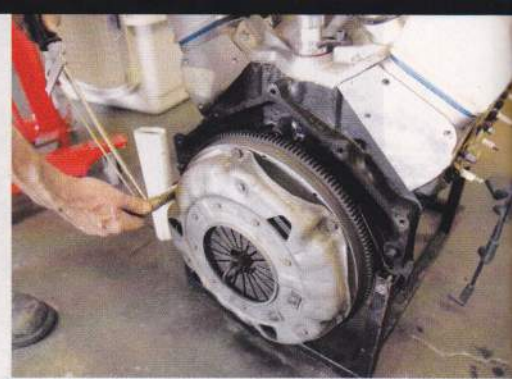
Prior to dropping the engine in place, we roughed up the flywheel and pressure plate with some 40-grit sandpaper and thoroughly cleaned all the mating surfaces with brake cleaner prior to assembling the clutch and torquing it in place.

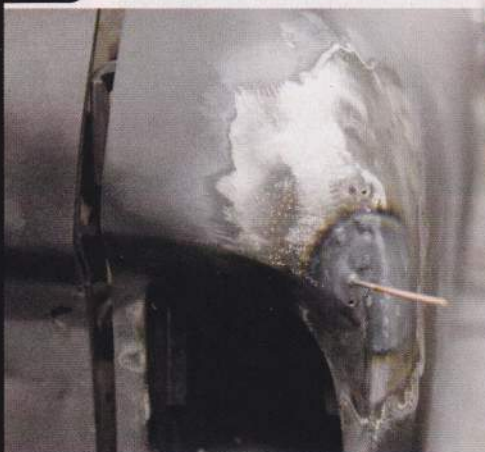
We started at the outer perimeter of the dent and gradually pulled it from the outside in to the center of the dent using the weld-on studs and a slide hammer. Sometimes the slide hammer will cause the stud to break free from the panel, leaving holes like you see above and below the remaining stud in this picture. That's normal. Don't stress too much over it. The holes are small and easily filled with a torch and some filler rod or a MIG welder. We are still working on this dent; the crease is almost gone, but we need to shrink the metal to the left of the dent more.

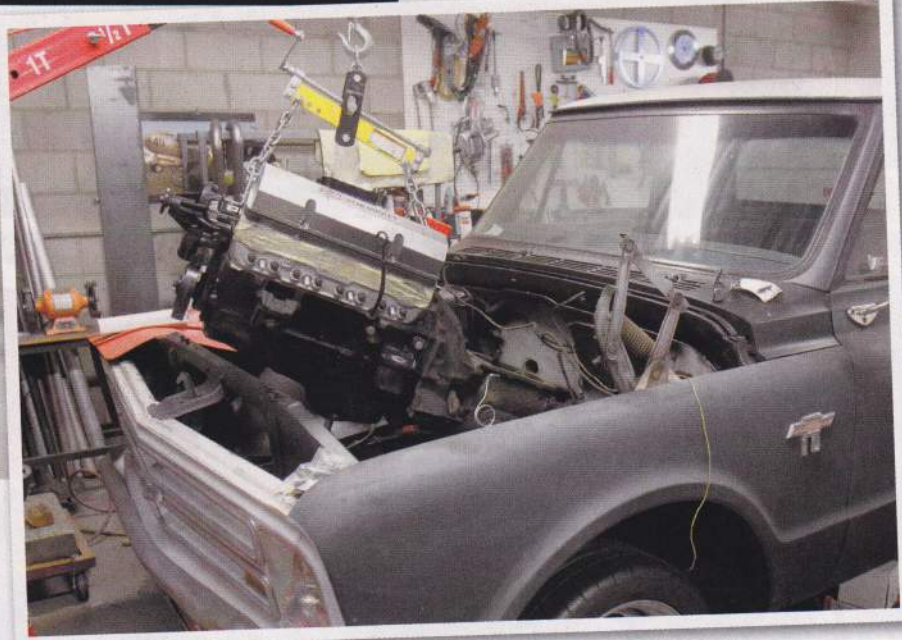
Though it's a physically small transmission, the SM420 four-speed weighs a formidable 135 pounds of unwieldy cast iron. We discovered early on that it's much easier to install the transmission to the engine outside of the truck, rather than installing it from the underside. We did that with the engine hanging from the hoist and the transmission on a moving dolly. Then, with the brake master cylinder out of the way and a good engine hoist load-leveler, it's actually quite easy to drop the pair into the truck. This is the 383 Chevy built by IMM Engines in the Nov. 2013 issue.

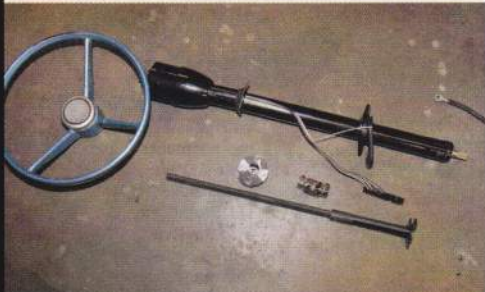
Our stock steering column was completely worn out, as indicated by the (at least) 1/4-inch side-to-side movement of the steering wheel. CPP provided a replacement column, complete with a new steering shaft, universal joint, and steering coupler (rag joint). We will pair that assembly with our original 1967 steering wheel we purchased on eBay last year.

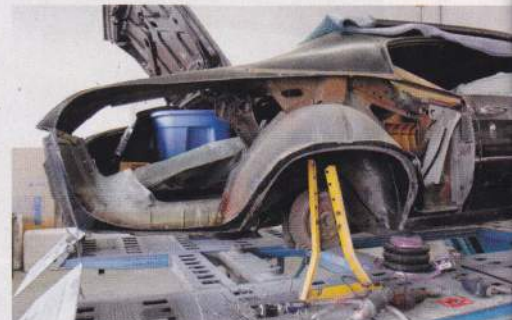
Meanwhile, as all this work is happening at the warehouse, our 1972 Chevelle is at MASCAR Auto Body and Paint Repair in Costa Mesa, California, for some bodywork. Here is preview of the quarter-panel replacement. We will cover this work in more detail in an upcoming issue.
