PROJECT CAR UPDATE

Truck Norris: The Little Details

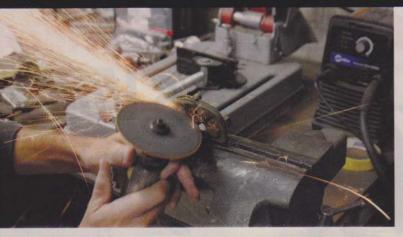
To rebuild the old rag joint, we first had to remove the rivets holding the upper and lower section together. We did this by first grinding the heads until they were flush, then driving them out with an air hammer.

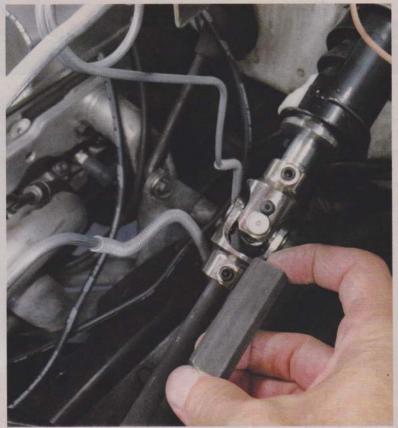
CPP's steering column kit includes a cut-to-fit intermediate shaft to connect the steering box and rag joint to the column at the firewall. We needed to trim about 2 inches from the intermediate shaft in our chop saw, then we were able to button the whole assembly up.
