ONE GOOD TURN

AN EASY UPGRADE FOR YOUR WORN STEERING GEAR

WORDS AND PHOTOGRAPHY BY CHUCK HANSON

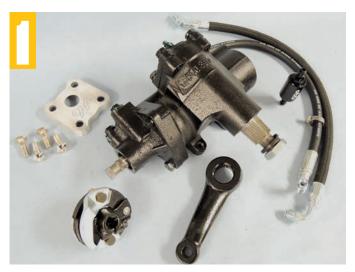
After bolting the new CPP steering box in place, we found that our Chevelle's steering wheel was improperly indexed by 180 degrees. The rag joint mates to the steering shaft with a pair of bolts, one larger than the other, to ensure that it can only be assembled with the correct orientation. Research led us to a different rag joint that bolted to the new steering box and maintained proper indexing. We don't know if this was an assembly line anomaly, if a previous owner swapped steering columns, or if we simply ordered the wrong part with the steering box. Our easy solution was to substitute a Dorman rag joint, part number 31011.

Using the steering shaft retaining bolt as a reference, the different-sized bolts that retain the CPP rag joint (L) and the Dorman substitute (R) are quite discernible.

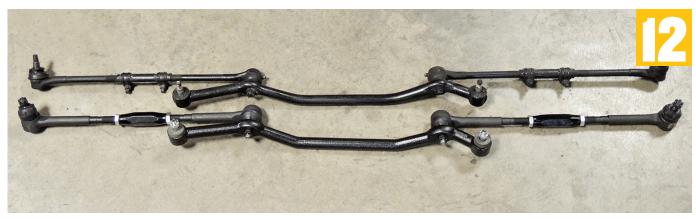
13. The idler arm from CPP is noticeably beefier than the original we replaced. The idler retaining bolts are cinched down to 55 ft-lb. 14. The final step is to reattach all the steering linkage, securing the castellated nuts with cotter pins once they are properly torqued to 35 ft-lb. Install the grease fittings and lube each one to complete the job.
