STREET SWEEPER

BUM STEER

A little preventative maintenance with some new steering adjuster sleeves from CPP may save you big headaches down the road.

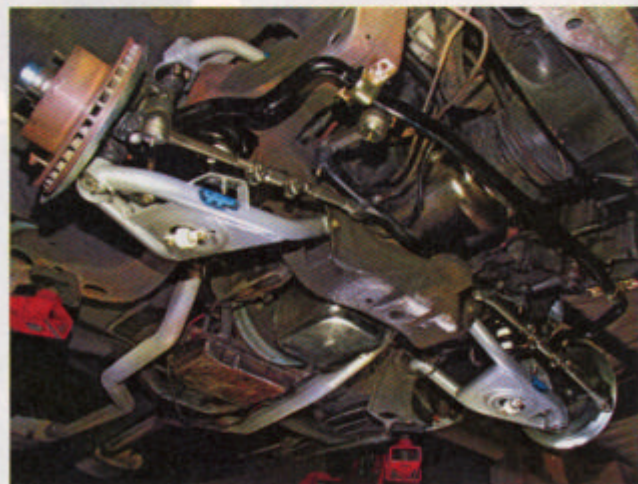
Last year, we upgraded to CPP's front-end package of tubular upper and lower control arms, springs, anti-swaybar, idler arm, and inner and outer tie-rod ends with new stock adjuster sleeves. This photo shows our setup at the time it was upgraded. This view does a good job showing the overall geometry and function of the GM A-body steering design: steering input comes from the Pitman arm attached to the steering box. That motion is transferred directly to the drag link—sometimes called the relay rod (center). The idler arm provides a neutral pivot point, and is geometrically similar to the Pitman arm. The tie rods are the links that transfer motion from the drag link to the spindle. A failure from any part of the system can result in a loss of steering. Not good.

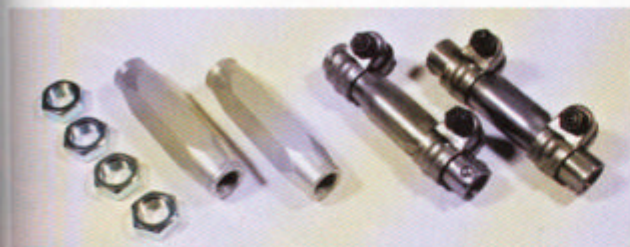
The Chevelle's tie-rod adjuster sleeves: the heavy-duty aluminum hex sleeves on the left (CPP PN ES2032SP-AR, \$69 per pair), and the stock sleeves (CPP PN ES2032S, \$9.00 each). Note the locking jam nuts that come with the aluminum sleeves.

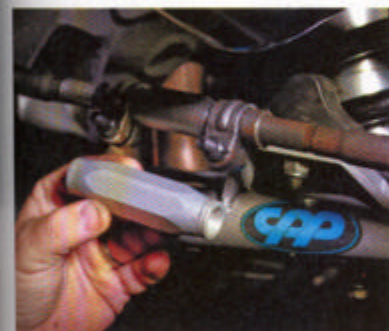
Besides the lighter weight of CPP's aluminum sleeves, there is some added practical utility. The stock sleeves are stamped from steel, and leave crevices for water and road dirt to accumulate. Over the years, rust can develop, causing the clamp nuts to freeze in place.

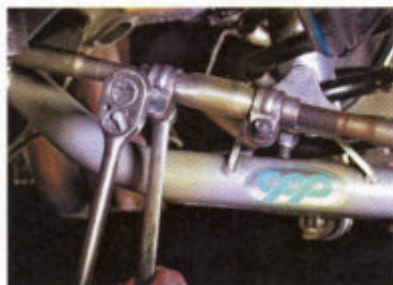
Our stock adjuster sleeves were only a year old, so they came off relatively easy. If your Chevelle still has the stock ones, you might be in for a bit of a fight. Before removing the old ones, take down measurements for the length—even if you're not replacing the tie-rod end links. Our inner and outer end links were replaced last year, but we've included the CPP part numbers in our chart. Note that the '64-'70 tie rods are all the same, but the '71-'72 tie-rod end links have different threading.

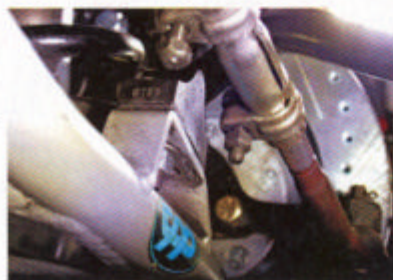
At some point, your Chevelle will need an alignment, and the toe-in will be set using the tie-rod adjuster sleeves. The sleeve will be set where the alignment is best, without regard to where that places the stock clamp nuts. This photo illustrates that this may not always be in the most ideal location, and may be too close for comfort for some tool access. The hex stock of our new pieces eliminates this problem.

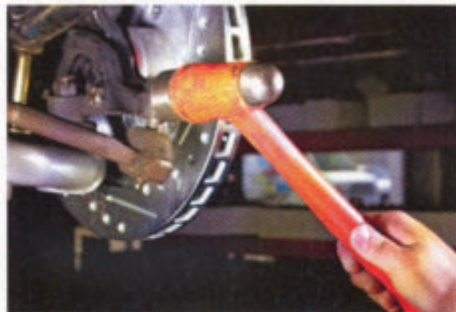
If you're just replacing the adjuster sleeves, you only need to disconnect the outer tie-rod end from the spindle. You should have no vertical movement of the tie-rod coupling on the spindle—if you do, it's time to get new tie-

rod ends. Use a mallet to loosen the tie-rod end from the spindle (after removing the cotter pin and castellated nut). Use a pickle fork at your peril: it will usually ruin everything it touches.

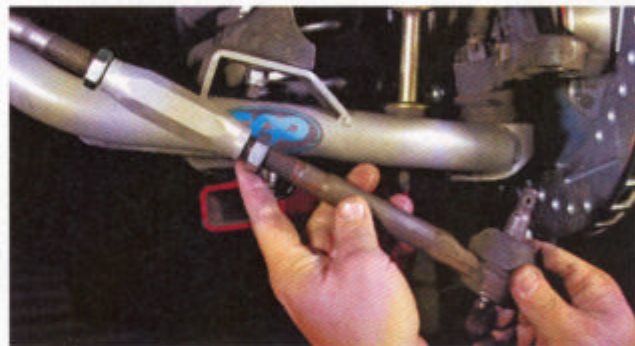
Thread the adjuster sleeve onto the inner and outer tie-rod ends after you have threaded the locking jam nuts on. Make sure you turn both ends the same number of times, comparing the overall length to the measurements you took earlier. When you get them the right length, tighten the jam nuts.

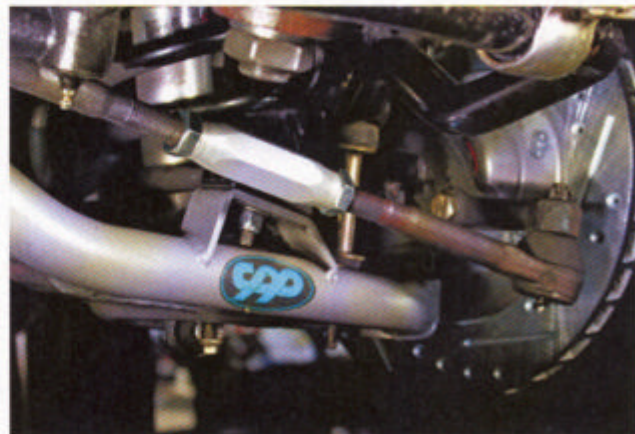
With the tie rod lengths set to your old specs and the end-links reattached to the spindles, you should be able to drive to the alignment shop with no problem. Note the machined groove on the left side of the adjuster sleeve—this indicates a left-hand thread on that side (the inner tie-rod end).
